EROSION AND SEDIMENTATION CONTROL (HYDROLOGY): RIO BLANCO RIVER RESTORATION

Conducted by: San Juan Water Conservancy District
 On the Web: www.epa.gov/owow/nps/Section319III/CO.htm; www.waterinfo.org/rioblanco.html
 Contact: Jerry Curtis
 Project Partners: Lower Blanco Property Owners Association, Southwest Water Conservation District, Wild Land Hydrology, Colorado Water Conservation Board, Colorado Division of Wildlife, Water Information Program, U.S. Bureau of Reclamation, Colorado Division of Water Resources
 Contract Period: 1996 to 2002
 NPS Funding: \$346,000
 Matching Funds: \$351,000

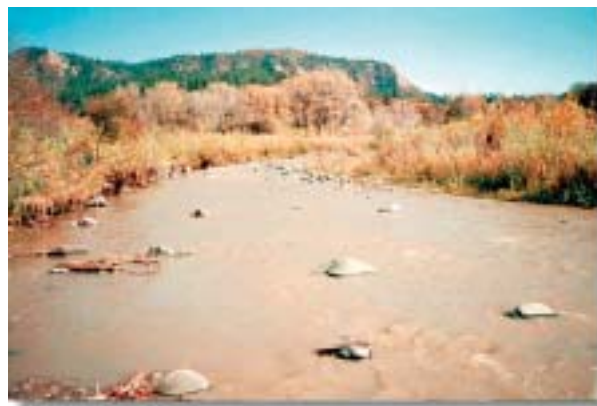
Unfortunately, the by-pass flow rates (water left in the river) established in the original legislation proved inadequate, and the streambed began to degrade.

The diversion of water, along with upstream sediment flushing, reduced the depth of the riverbed and increased water temperatures. The effect was a marked decrease in the fish population and an altered riparian zone.

The Rio Blanco before restoration work.

Construction of the demonstration project began in 1999 with heavy equipment being used to narrow and deepen the river channel. In addition, rock weirs and other bank stabilization measures were put in place. Pools that had become only inches deep were now 6-7 feet in depth.

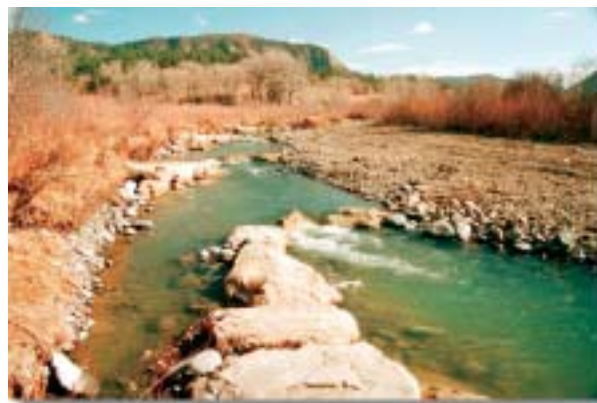
By December of 1999, 1.1 miles of the project were completed. Data show the channelization and bank stabilization are creating a positive result. Initial water temperature data collected during the low-flow, high-temperature summer months show a reduction of

1.75 degrees in the demonstration area as compared to an area upstream, and fish populations appear to be on the rise.

The Rio Blanco after restoration work.
