EROSION AND SEDIMENTATION CONTROL (HYDROLOGY): STRAIGHT CREEK DEMONSTRATION PROJECT

Conducted by: Colorado Department of Transportation
 Contact: Theresa Tiehen, CDOT
 Contract Period: 1992 to 1995
 NPS Funding: \$121,718
 Matching Funds: \$86,373 plus maintenance costs

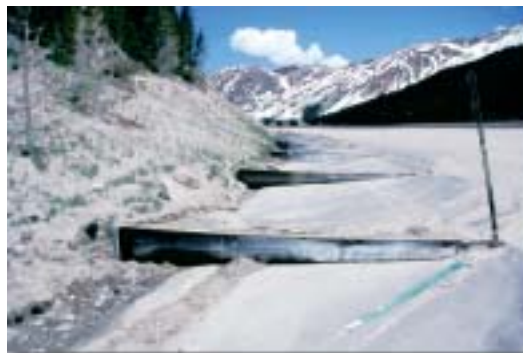
Check dams along Interstate 70

CDOT considered various designs for check dams taking into consideration federal highway requirements, environmental conditions, maintenance and safety issues. The result was a modified silt fence of fabric between two unistrut posts as well as a top and bottom rail. The check dams were 14' wide and two feet high.

Three test sections were selected for construction for a total distance of 2.3 miles. In order to create a consistent, hard surface for the containment and recovery of the material, the full width of the ditch section and vehicle recovery zone adjacent to the westbound lanes (approximately 25' in width) was paved. The check dams were placed at 20-foot intervals.

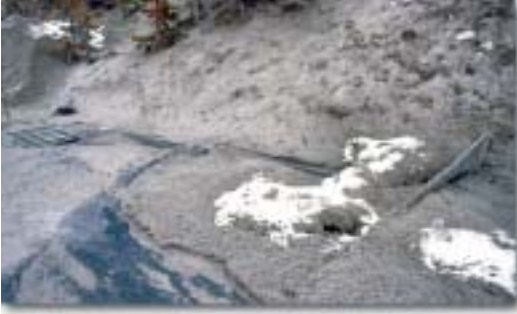
Material build up behind check dams

During the summer of 1993, more than 1,100 tons of material were removed from the 180 installed check dams — an apparent removal of 14.4% of the material applied to the highway. In 1995, approximately 75 of the 220 check dams were cleaned out and 225 tons of material were removed.

Unfortunately, estimates from 1995 showed that of the material removed, there were approximately 3 tons of rock for every ton of sand. While the check dams were working, the volume of material other than sand created large demands on maintenance operations. In addition, the large volumes of material caused damage to the check dams.
